MEMORANDUM

SUBJECT Site Assessment: R.V. Hopkins, Inc., Davenport, Iowa
TDD: T07-9311-030
PAN: EIA0042SAA
EPA/OSC: Jim Kudlinski

INTRODUCTION

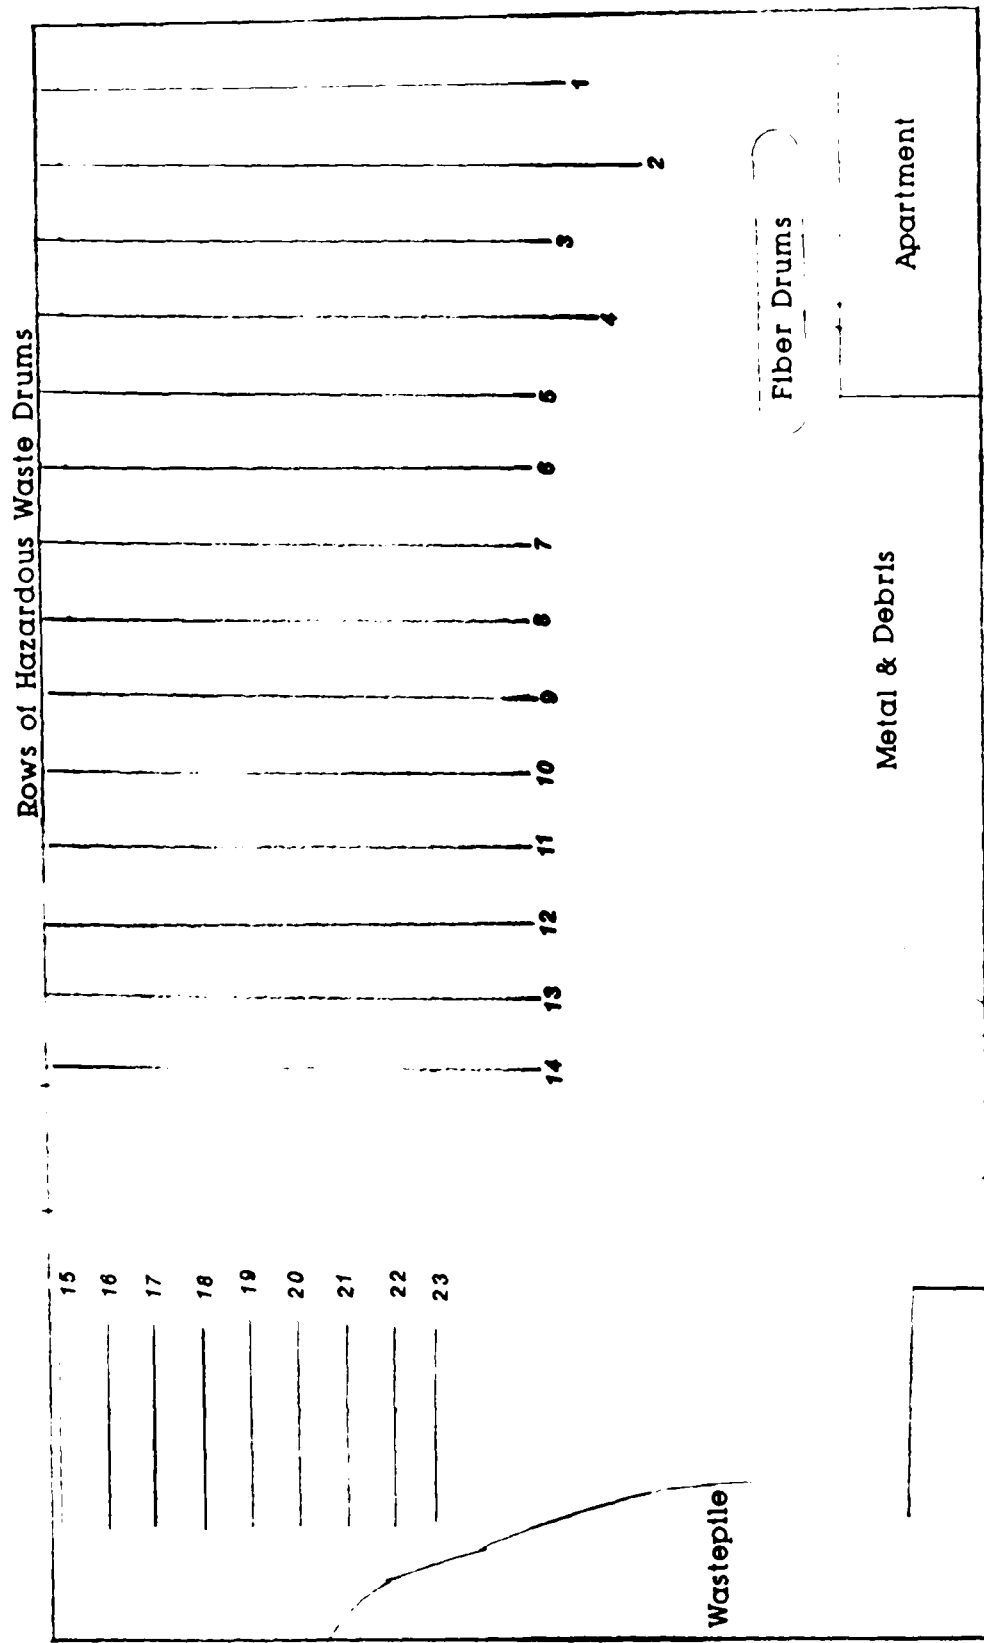
SITE SKETCH OF WAREHOUSE

R.V. Hopkins, Inc.
743 Schmidt Road
Davenport, Iowa

NOT TO SCALE

stacked three to four pallets high. When a drum was observed to be leaking, bulging, corroded or leaning, a photograph was taken of the containers, and its location and condition noted in the logbook. The location of the drum was identified by: row number; tier; eastern, middle or western third of the row; and whether it was on the north or south side of the row. The photographs presented with this report indicate the drum's location and condition. By the end of the day, rows number 1 and 2 had been inspected and potential problem drums identified and documented.

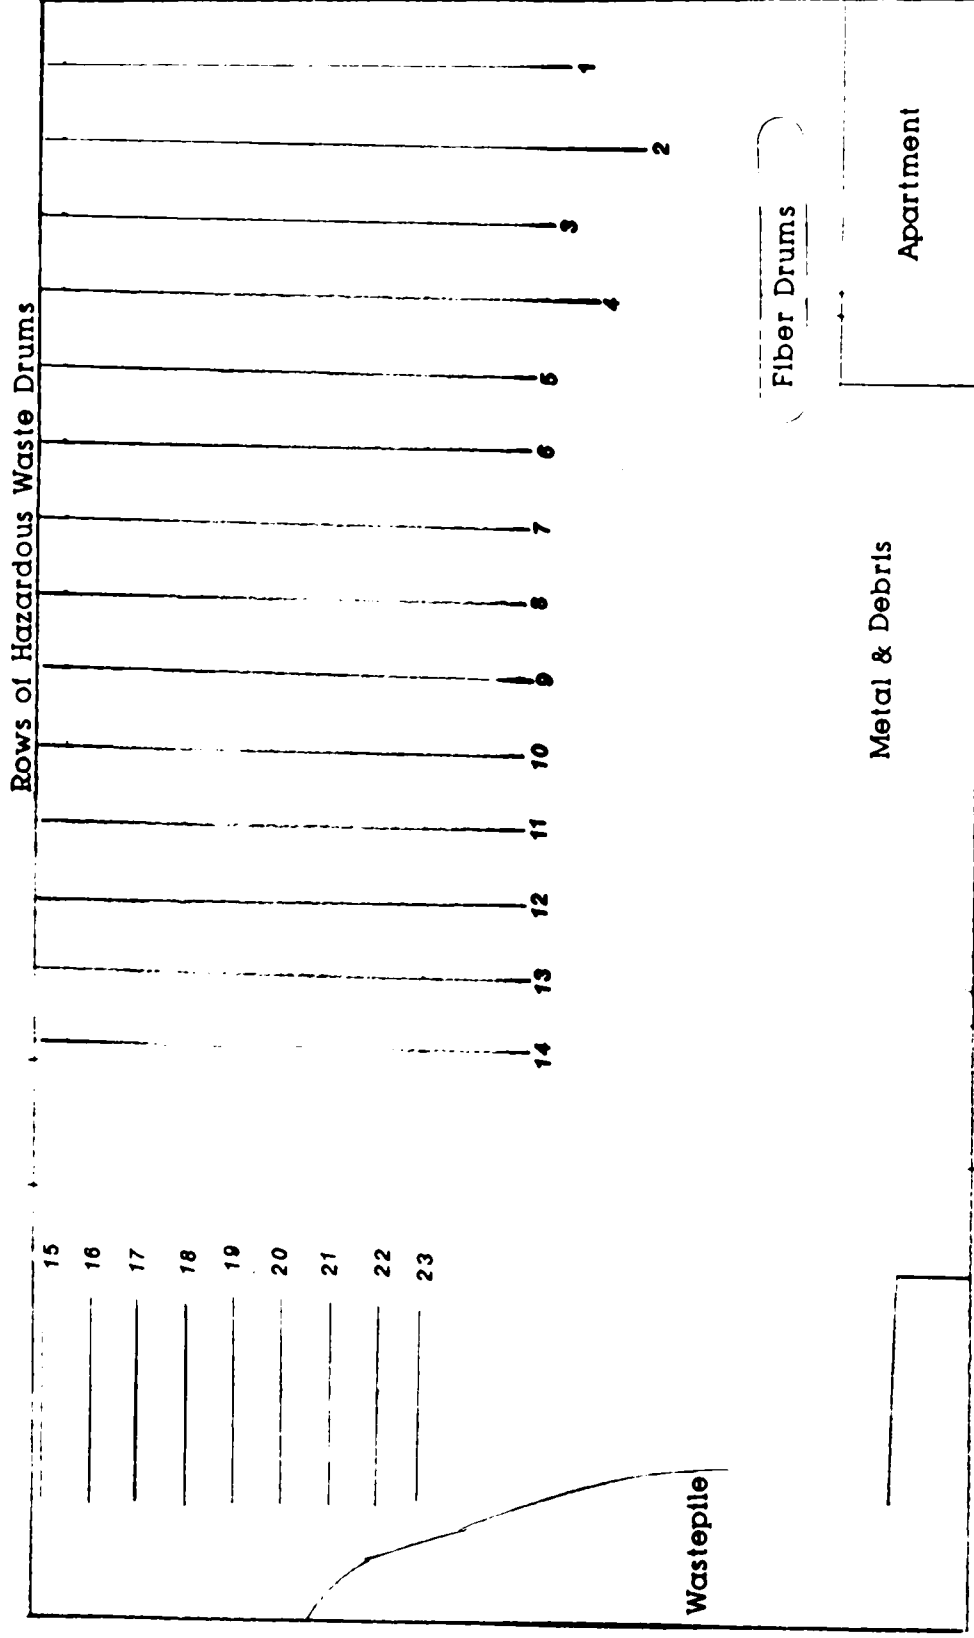
SITE SKETCH OF WAREHOUSE

R.V. Hopkins, Inc.
743 Schmidt Road
Davenport, Iowa
